## 海洋地理資訊系統實驗室

### 以橢球高進行水深測量之探討

### • 臺北港附近海岸水深資料品管及地形變遷特性之研究—應用斷面迴歸與經驗正交函數分析

# Marine Geographic Information Systems Lab.

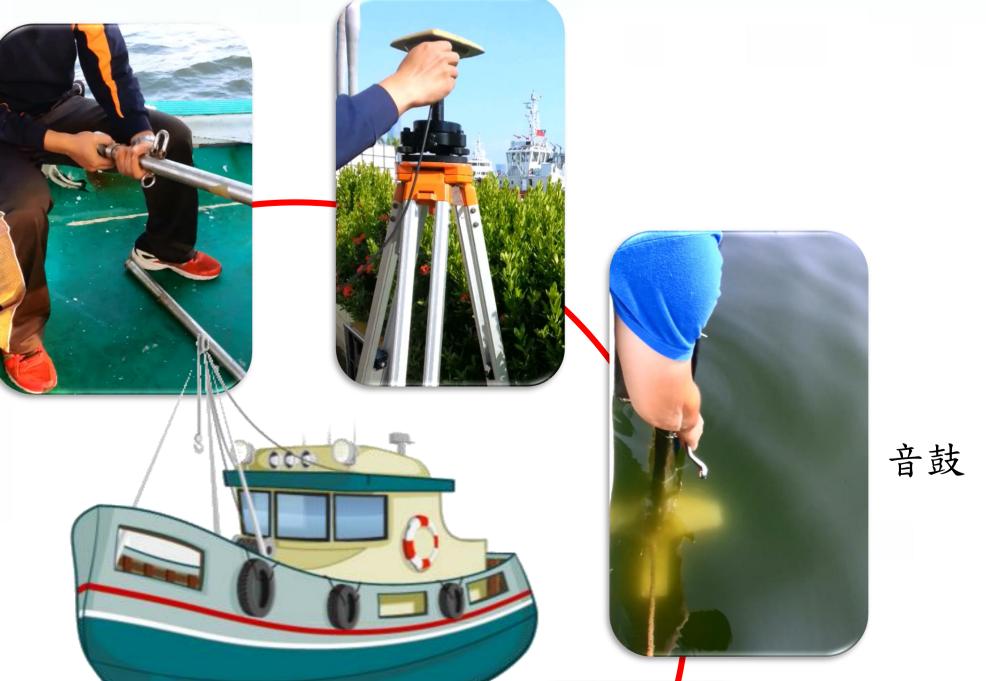
船隻姿態感測儀
